مبادرة بيروت للتراث
BEIRUT HERITAGE INITIATIVE

Report

September 2020 - June 2021

TRACK RECORD

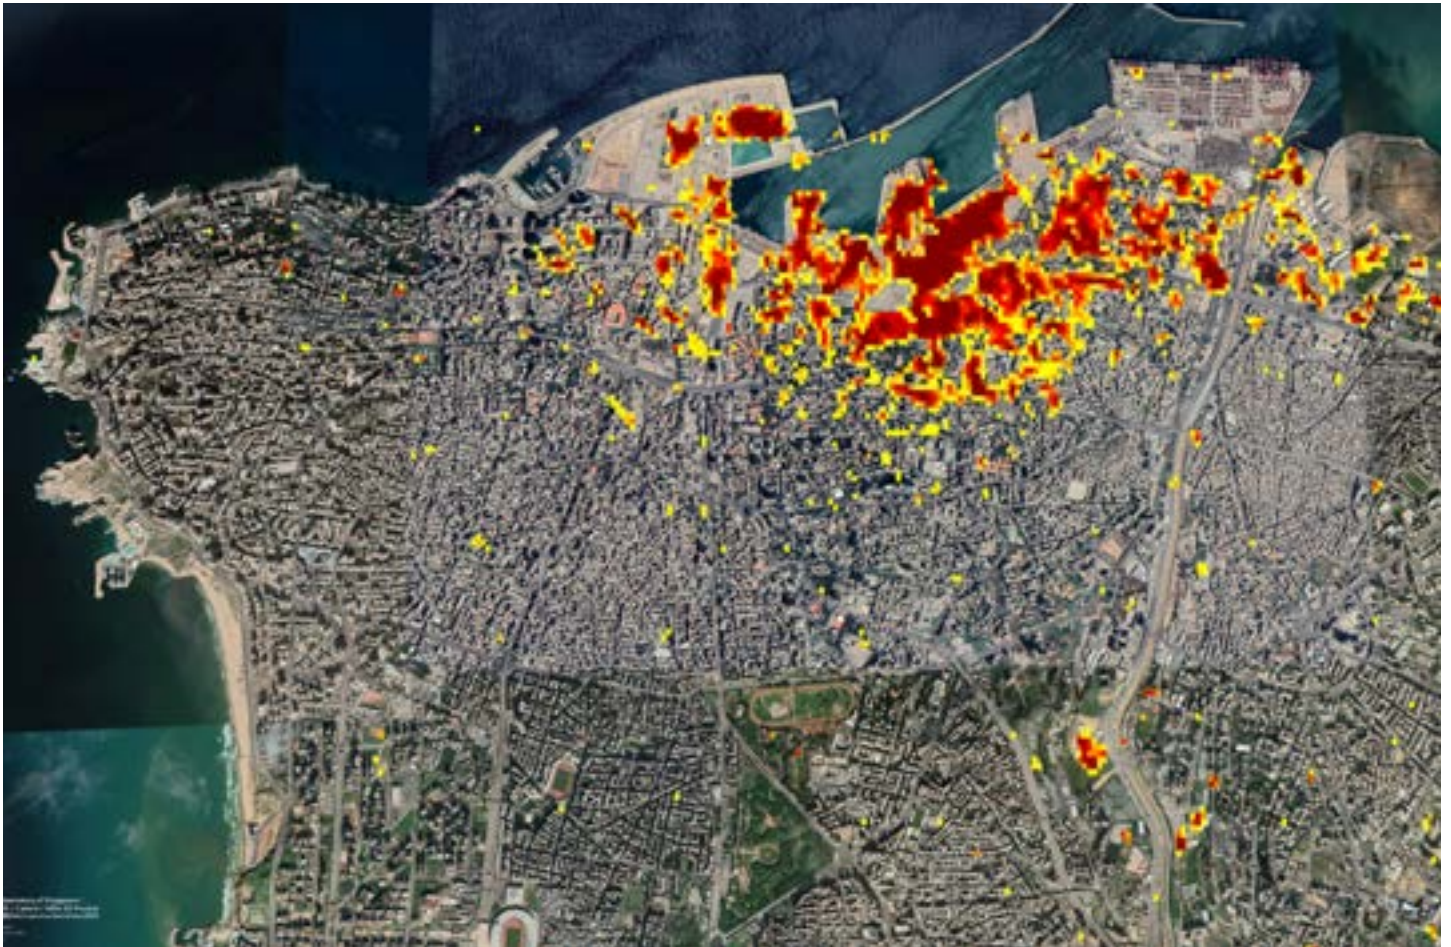
Damage Map by NASA, Google Earth

The neighborhoods that were the most affected by the explosion are located towards the southern and eastern ends of the harbor's third basin. The areas hardest hit by the explosion, such as Gemmayzeh, Mar Mikhael and Ashrafieh, also had the highest concentration of historic structures in Beirut. These neighborhoods are composed of cultural, educational, touristic, creative spaces, and small trades that perpetuate the city's valuable and intangible heritage. Moreover, buildings and homes of this area are occupied by inhabitants of different backgrounds and income levels. Throughout the capital's worst episodes in history, these neighborhoods remained inhabited and are living witnesses to Beirut's past and present. Thus, rescuing our endangered heritage is also part of preserving the city's historical and cultural identity.

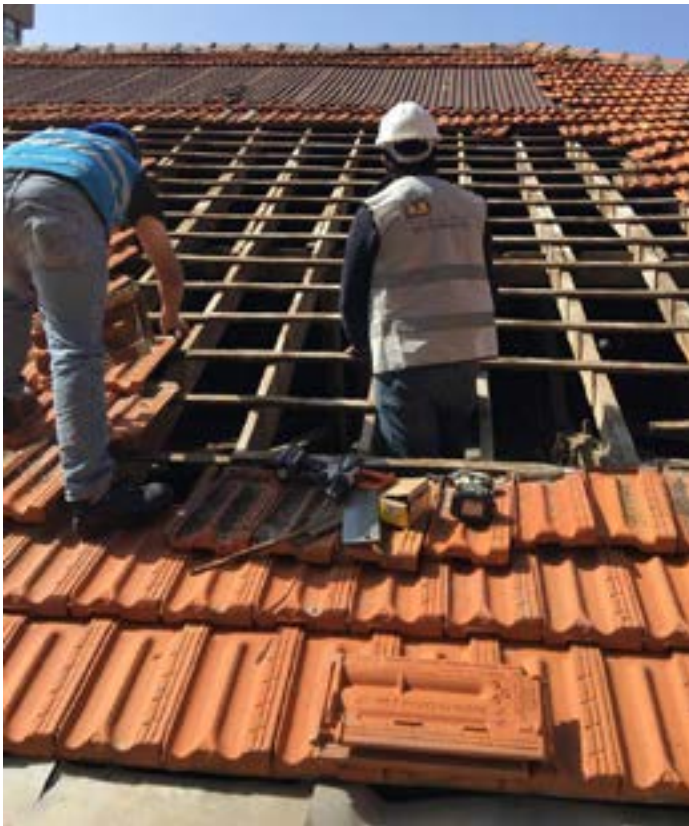
Tile Replacement, *Y. Kassab*

A- When the roof structure was not severely affected: Repairing the pitched roof wood structure and replacing the broken roof tiles.

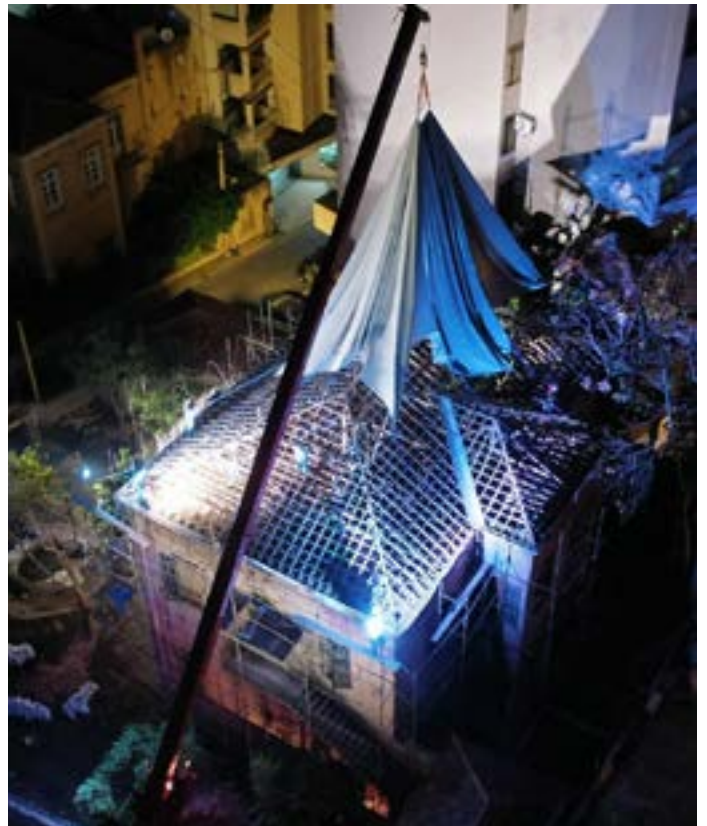
Tarpaulin Cover, *LiveLoveBeirut*

B- When the roof structure was severely damaged: Repairing the pitched roof timber structure with a temporary replacement and covering the building with a tarpaulin (*Belmark 550mg*).

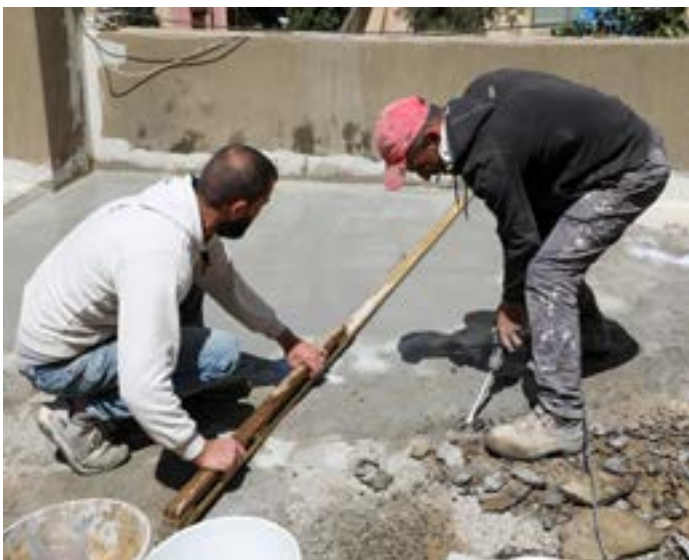
Waterproofing application, *D. Mrad*

C- When the roof is made out of a reinforced concrete slab (1930's - 1960's constructions): waterproofing application including grouting and slanting.

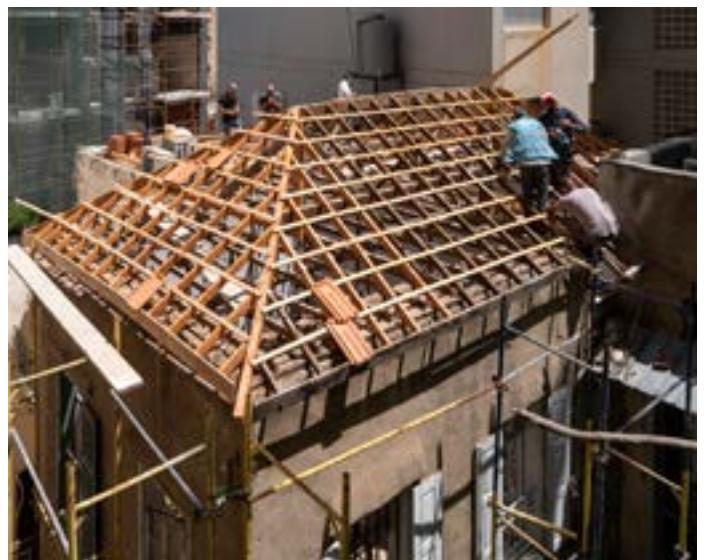
Roof Reconstruction, *D. Mrad*

D- Roof's that were covered with a tarpaulin cover, by *BHI* with *ALIPH* grant, are now getting a full reconstruction.

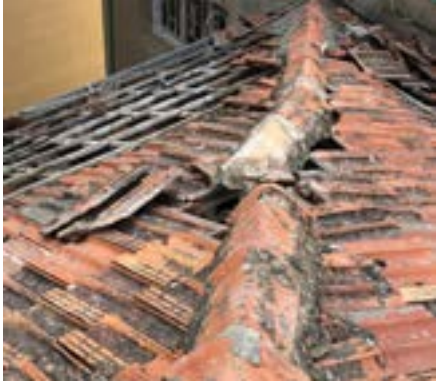
Ashrafieh 1139, after the blast, C. Acra

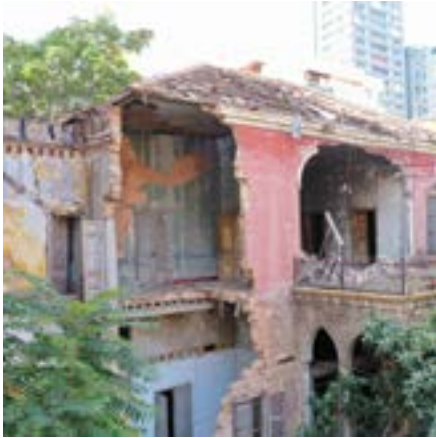
Ashrafieh 569, after the blast, *M. Gharzouzi*

Emergency propping and consolidation was executed on vulnerable heritage buildings, that require costly and time-consuming repairs and restoration.

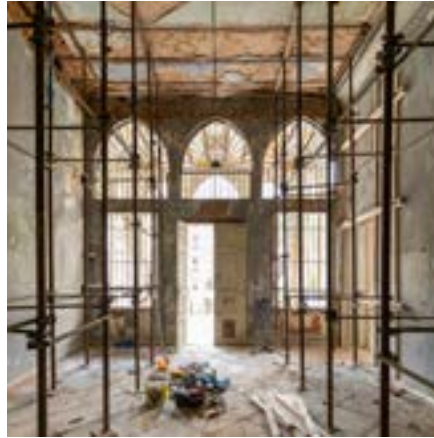
Interior propping, *D. Mrad*

Furthermore, BHI intervened on interior wall reconstruction and consolidation to secure the buildings structurally.

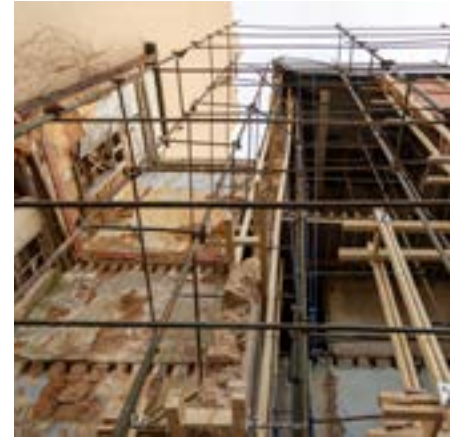
Emergency propping, *D. Mrad*

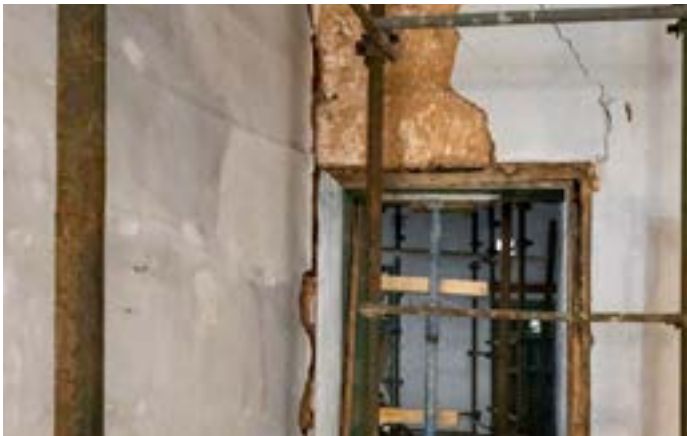
Rmeil 688, wall detachment, *D. Mrad*

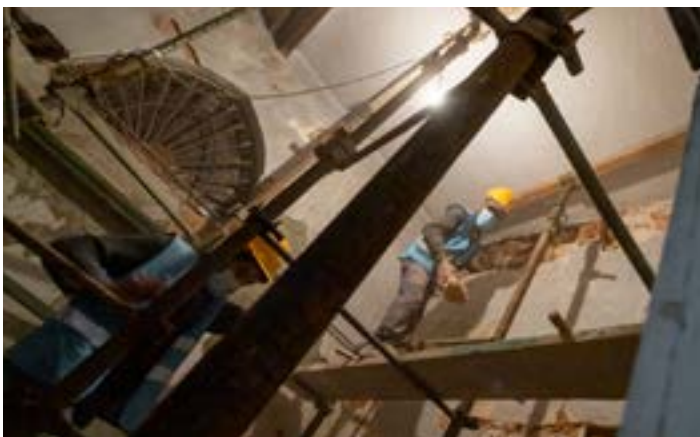
During the intervention, *D. Mrad*

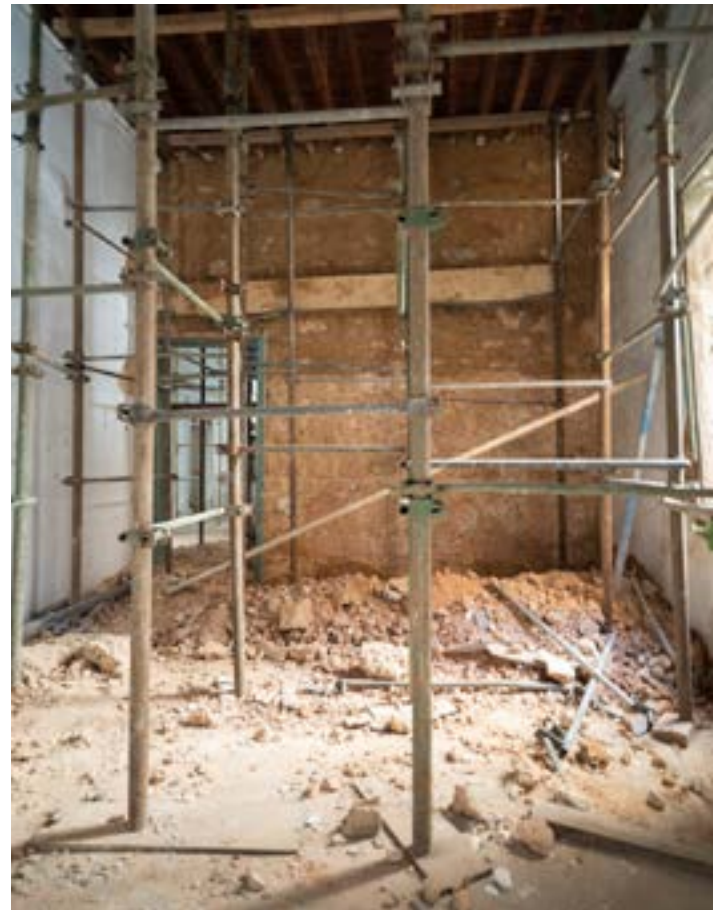
After the intervention, *D. Mrad*

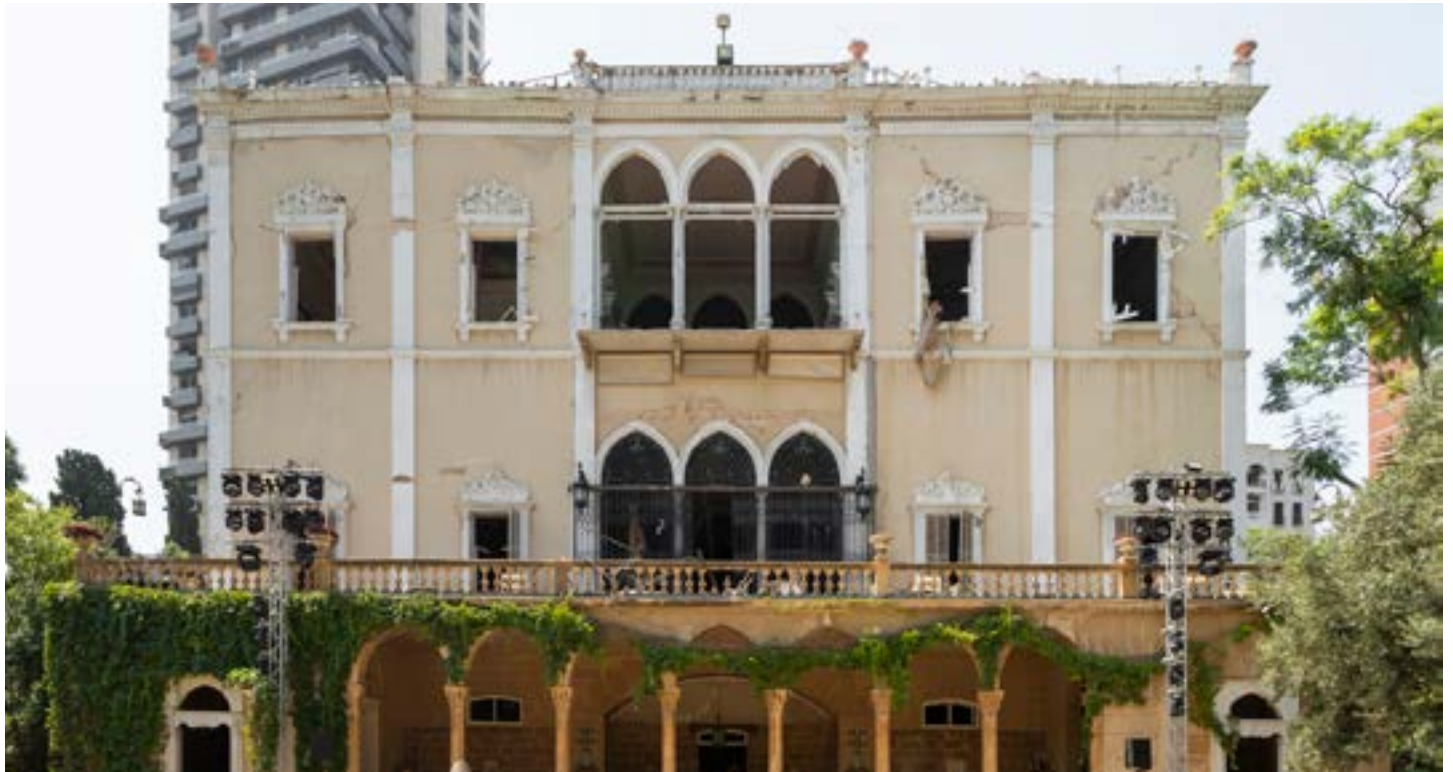
Sursock Palace North Façade, after the blast, *D. Mrad*

the Beirut port and the northern Lebanese coast, Sursock Palace has been severely affected by the blast on Aug. 4 2020.

The North facade (facing the port) has been detached from the rest of the building. Most of the woodwork is destroyed, and internal damages include large wall cracks, ceilings, walls and roof damages...

Due to the urgent need for structural consolidation, and the prevention of further collapse, a contracting company (*EDRAFOR*) chosen by the Sursock family, under the recommendation of *BHI*, and as per instructions from Michel Chalhoub (specialized engineer-restorer) supported the fragile North Facade with a steel structure.

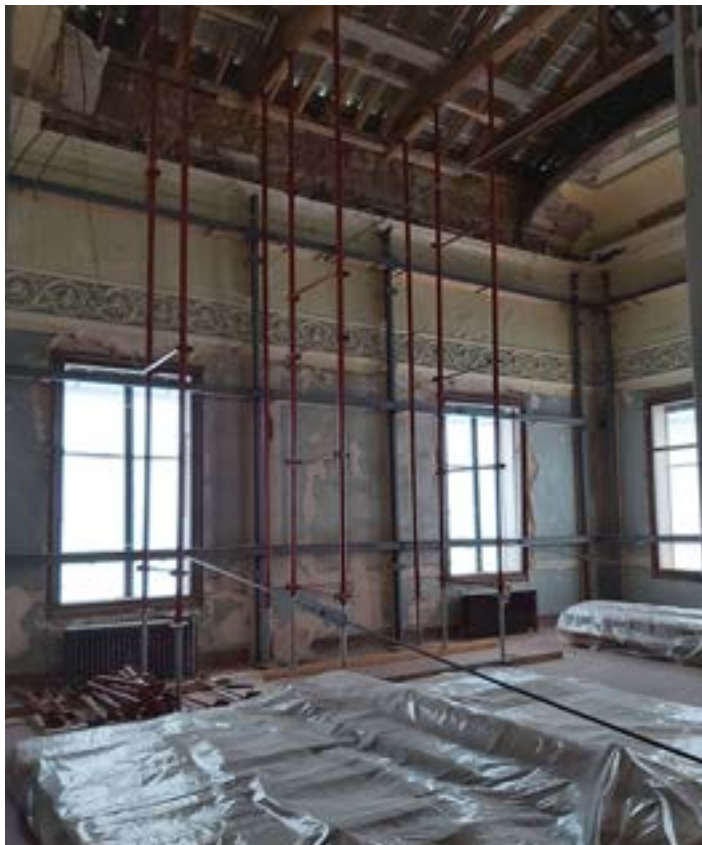
Interior propping and bracing, *Y. Dagher*

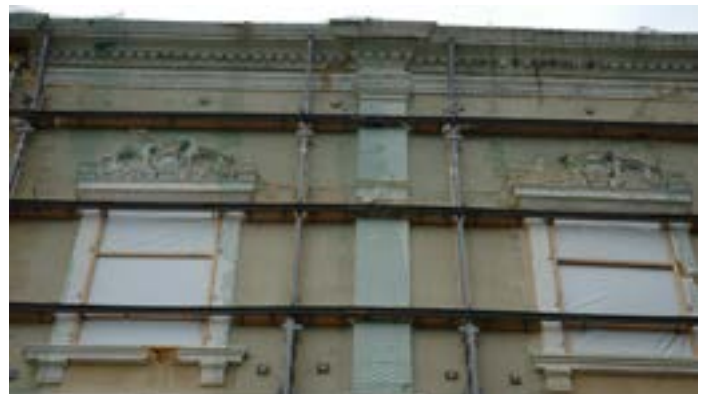
The bracing system on the facade, *Y. Dagher*

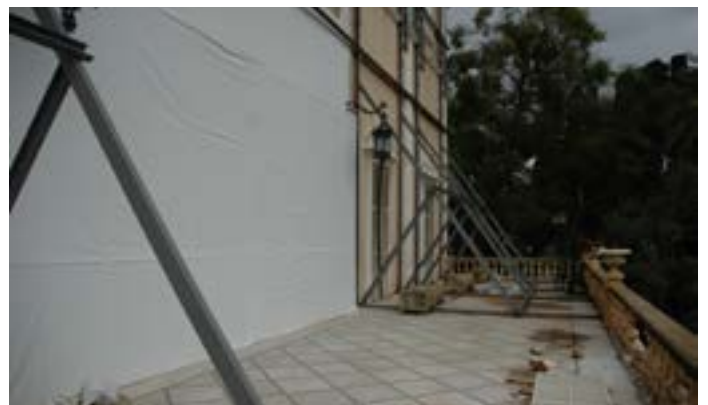
The shoring system standing on the balcony-terrace, *Y. Dagher*

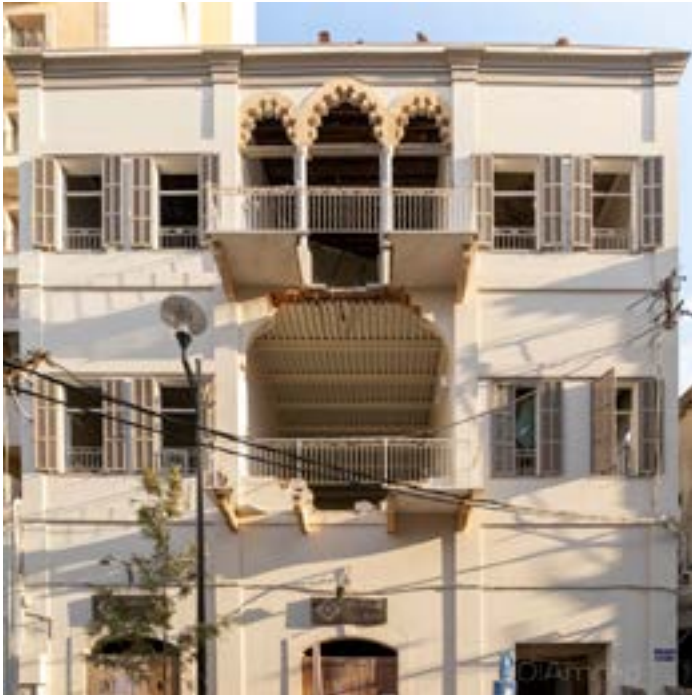
Rmeil 342, after the blast, *D. Mrad*

Beirut's built heritage is mostly known for its iconic triple arched bays facing North. The destruction of those arches left the interiors of the houses exposed and structurally vulnerable.

- The reconstruction of the sandstone arches and Carrara marble columns
- The restoration of damaged corbels or wooden beams that held the balconies' Carrara marble slabs
- Plastering of the newly constructed arches using lime plaster

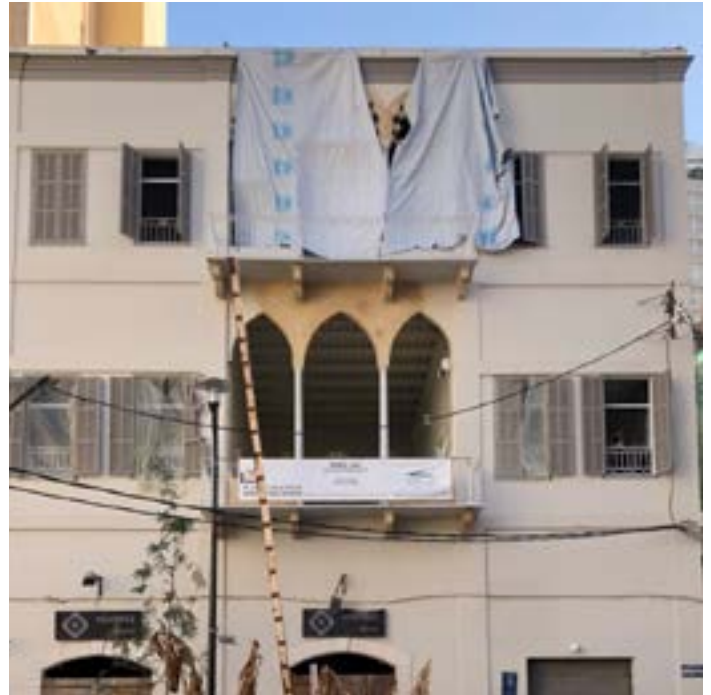
After the intervention, *Y. Dagher*

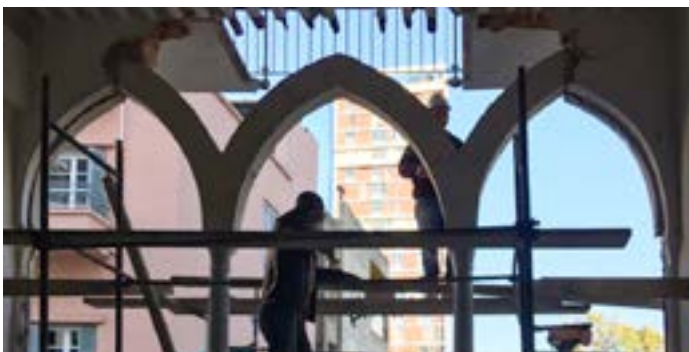
During the intervention, *Y. Kassab*

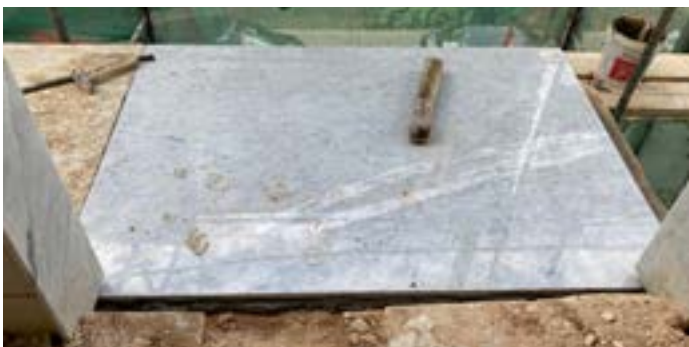
Balcony installation, *F. Dagher*

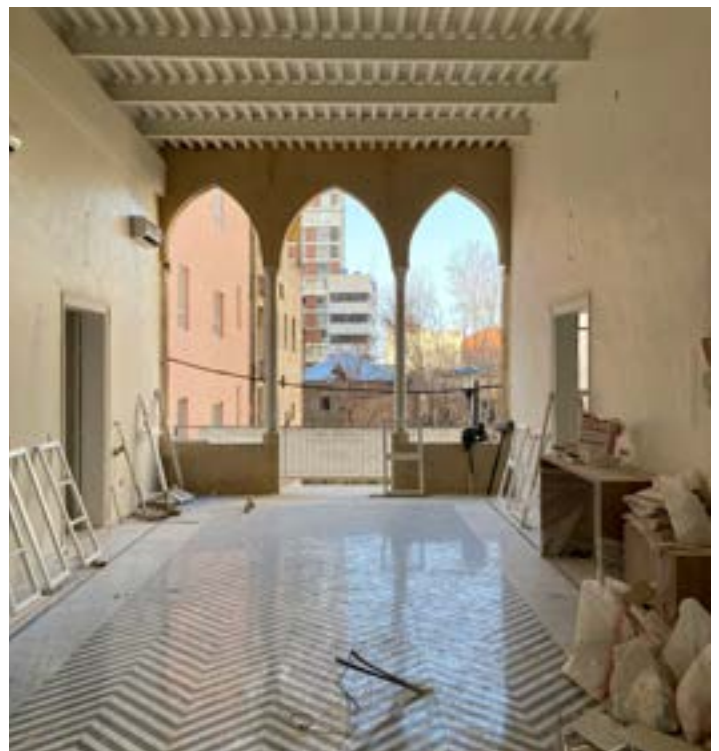
After the intervention, *F. Dagher*

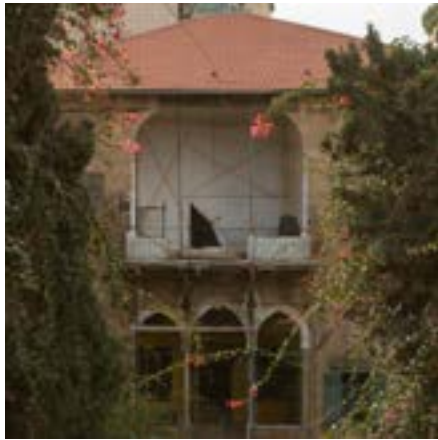
This heritage building was severely damaged. BHI's intervention consisted in the reconstruction of Northern façade's triple arches, with Carrara marble columns and sandstone arches, with plaster and carpentry works, as well as the restoration of the Carrara marble balcony laid on steel trusses and wooden beams.

Saifi 242, after the blast, *D. Mrad*

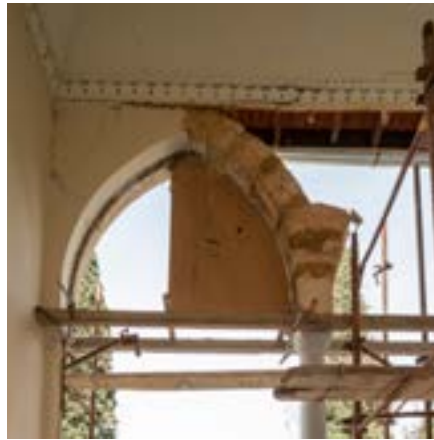
During intervention, *D. Mrad*

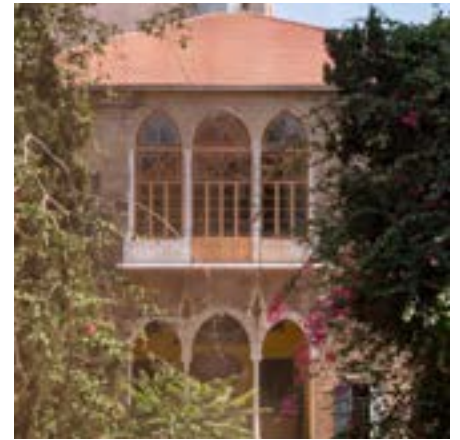
After intervention, *D. Mrad*

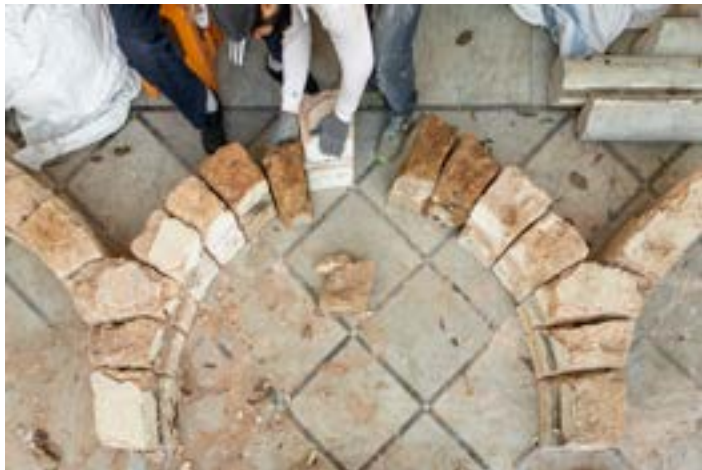
Laying of the fallen sandstones, *D. Mrad*

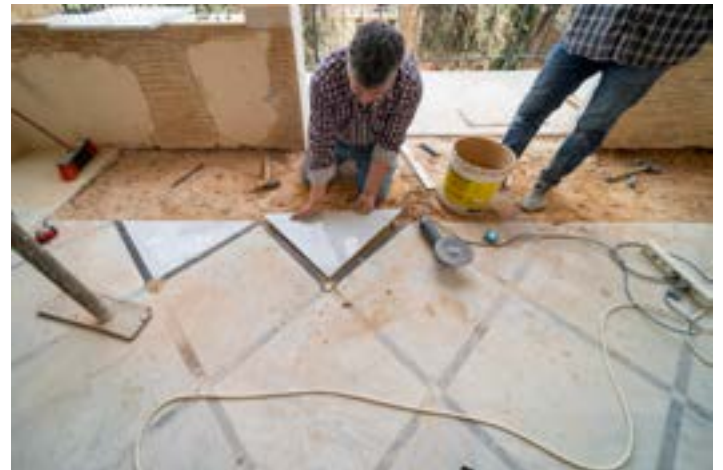
Replacing the broken Carrara tiles, *D. Mrad*

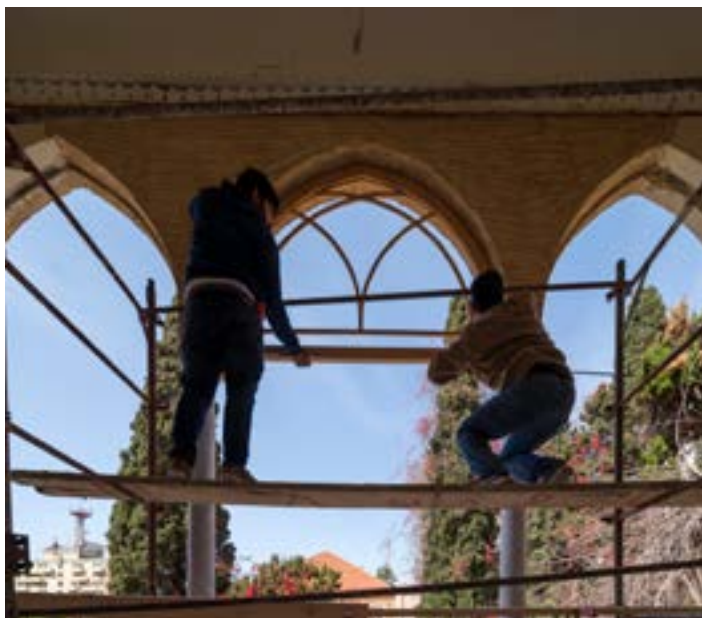
Carpentry installation, collaboration with *Bebw'Shebbek*, *D. Mrad*

- Reconstitution of *Qotrani* wooden windows and arches for the new facade, a project in collaboration with *Bebw'Shebbek*.
- Renovation of the damaged Baghdadi ceilings using traditional techniques.

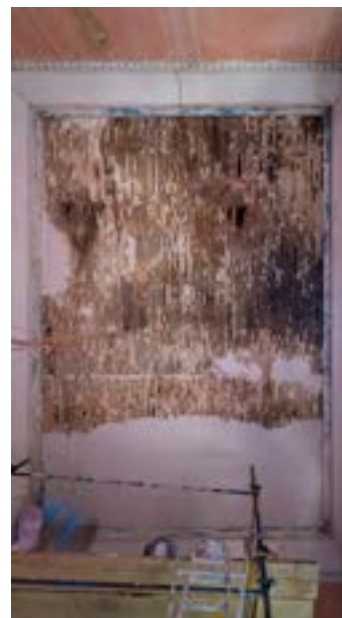
Repair of Baghdadi Ceiling, *D. Mrad*

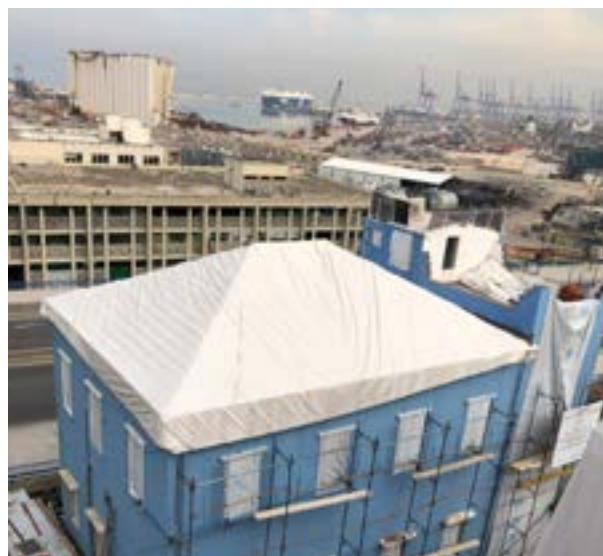
Medawar 479, known as “The Blue House”, is a heritage building located between Pasteur Street, and Charles Helou Avenue. Due to its utmost proximity to the port, the explosion inflicted eminent damages upon its structure.

Medawar 479, Facing the port, *Y. Dagher*

A generous grant allocated to *BHI* from the *Honor Frost Foundation* will enable its full restoration. The scope of restoration works includes structural consolidation, reconstruction of the pitched roof and the North facade, interior renovations, and MEP works.

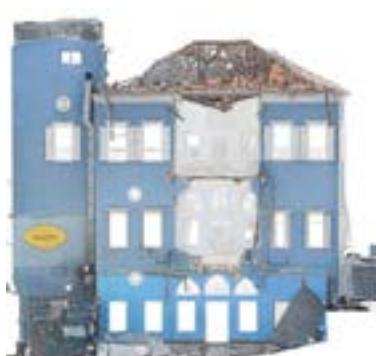
Damage mapping, *J. Kallas*

The restoration works will follow the guidelines of a thorough study conducted by Architect/Restorer Joe Kallas based on a request from the *DGA*. Furthermore, a tender was launched by *BHI* to assign an eligible contractor to execute the works. It is estimated that the chosen contractor will proceed with the restoration works in July.

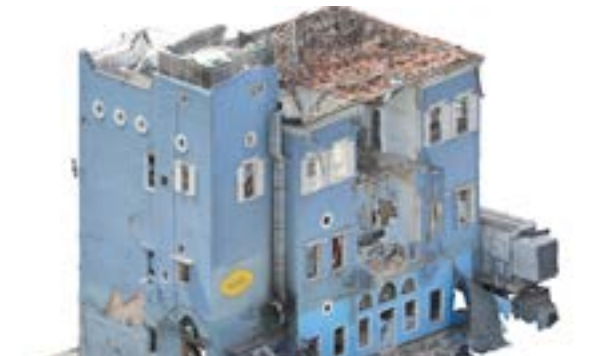
North-East 3D, *J. Kallas*

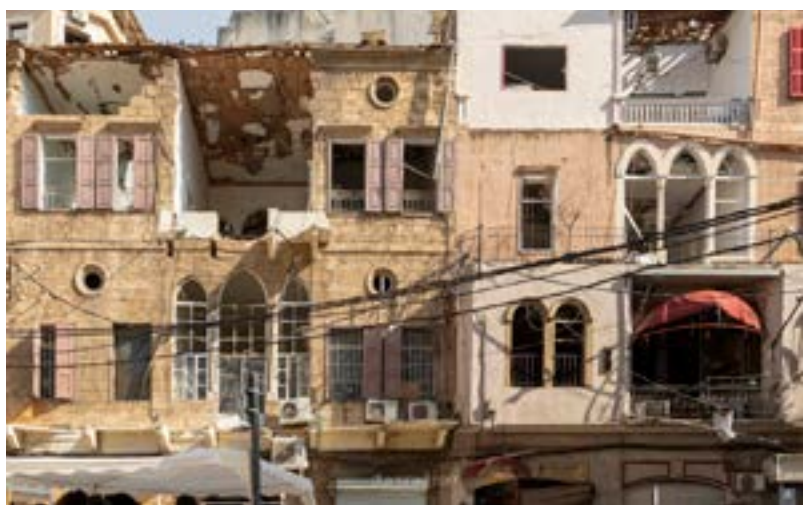
Rmeil 722, is a heritage building located at the juncture between Gemmayzeh and Mar Mikhael. Built between 1860 -1900, it is composed of a commercial ground floor and two residential floors. Severe damages have been inflicted upon this building as it lies along the direct axes of the port explosion. In October 2020, *BHI* sheltered the building under a grant from *ALIPH* to secure it from further damage during the winter storms. In April 2021, with the help of multiple donors, *BHI* was able to secure the fund needed for the building's full restoration. Consequently, *BHI* will be contributing to the safeguarding of the neighborhood's heritage cluster.

Rmeil 722, after the blast, *D. Mrad*

Restoration works will follow the guidelines of a thorough study conducted by Architect/Restorer Pierre Ghanem from *BBHR* which was commissioned by the *DGA* and funded by the *DAI*. So far, 15% of the works have been completed on site and the expected end date of the works is September 2021. In addition, a grant has been also allocated to the refurbishment of the Gholam Public Stairs by the French ministries of Culture and Ecological Transition.

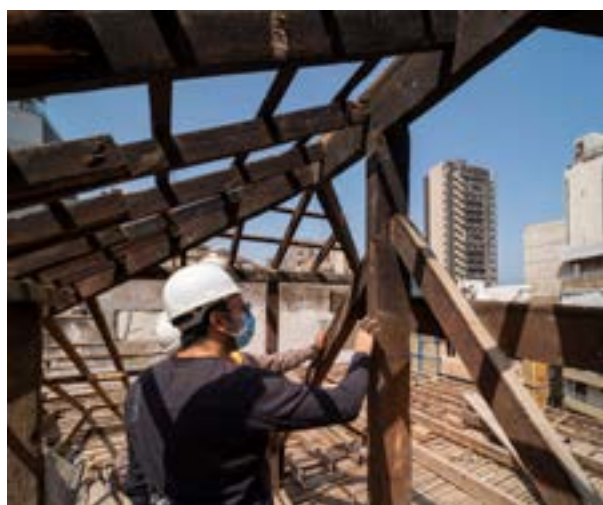
Inspection of the wooden structure, *D. Mrad*

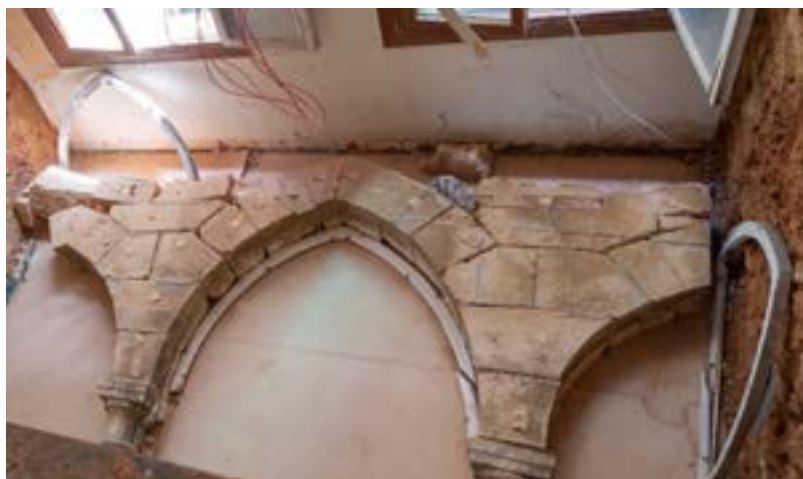
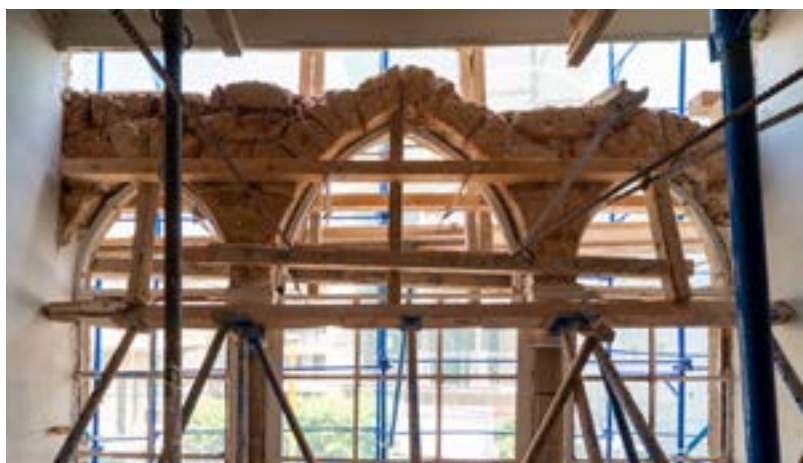
The dismantled arches, and their re-installation, *D. Mrad*

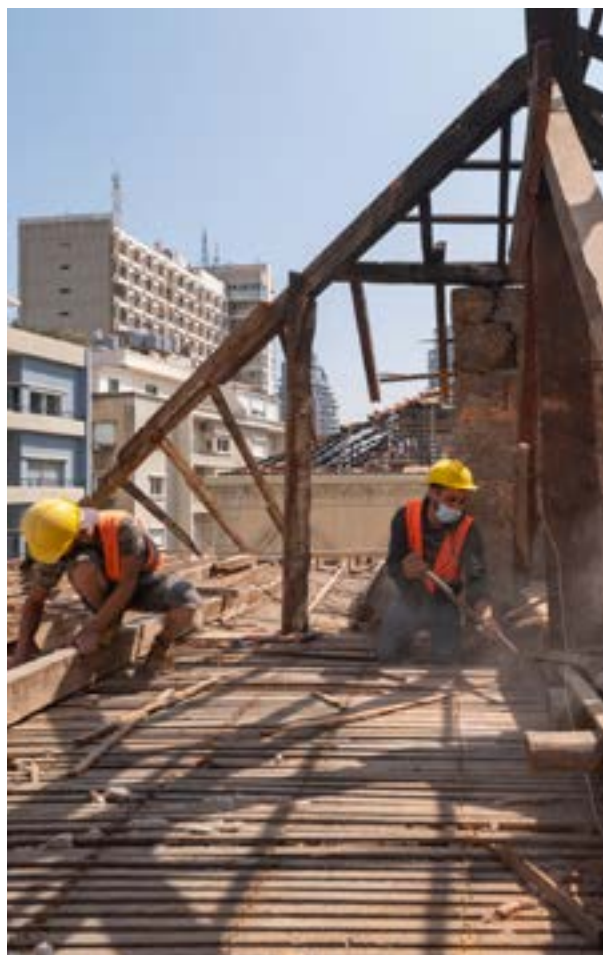
Roof works, *D. Mrad*

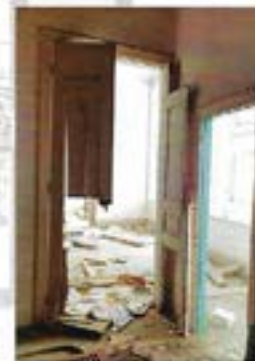
Building common space: window glass, frame and decorative elements in damage

Wooden doors, windows and shutters installation or repair along with painting works and glass installation
